Republic of Marshall Islands Maritime Investment Project

Description of Existing Ports

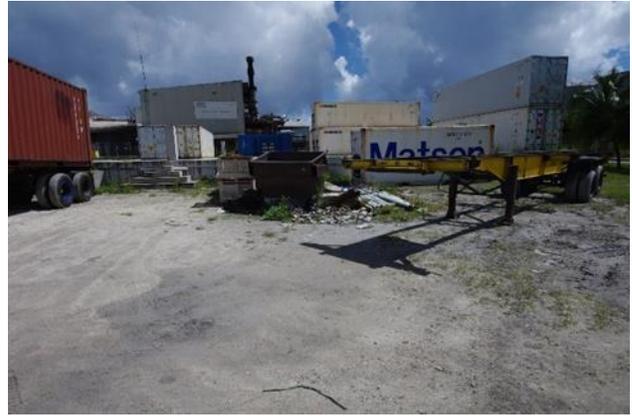
Waste within the Delap port

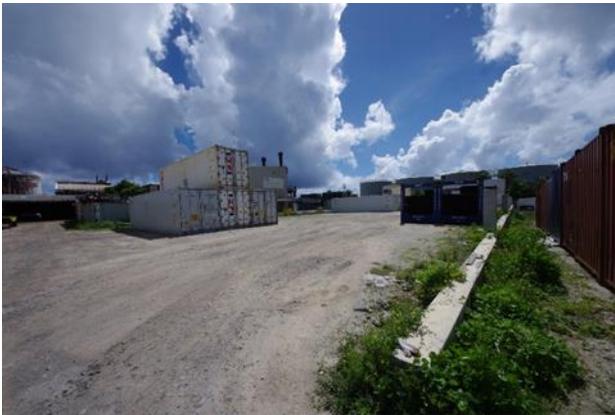
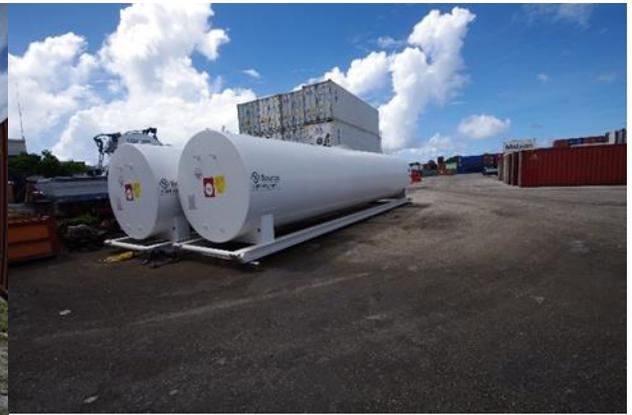
4. The container yard is 30,000 m² of crushed coral base. The surface is very uneven in places and could present safety issues for users. Water pooling was observed within the yard during the site visit immediately after rain. RMIPA indicated that between 10,000 and 30,000 Gross Registered Tonnage could be put through the port. The port has the capacity for 500 twenty-foot equivalent units (TEUs). There are presently ten (10) reefer stations. During the site visit in December 2018, numerous purse seine vessels were alongside however in February 2018, no vessels were observed alongside the port.

Liquids in the container yard in Delap Port

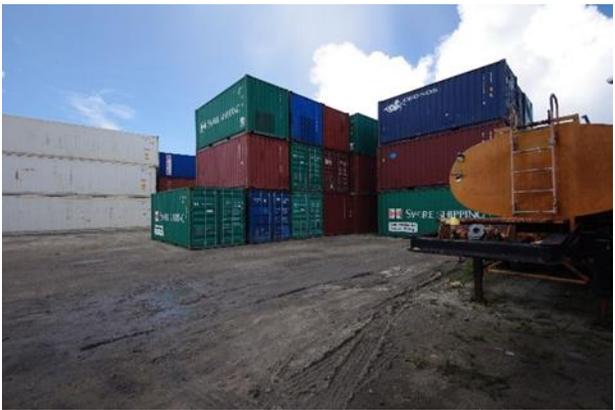
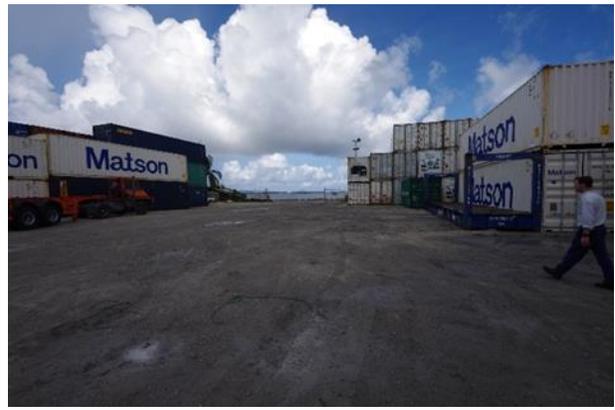
Wet Areas in the Delap Container Yard

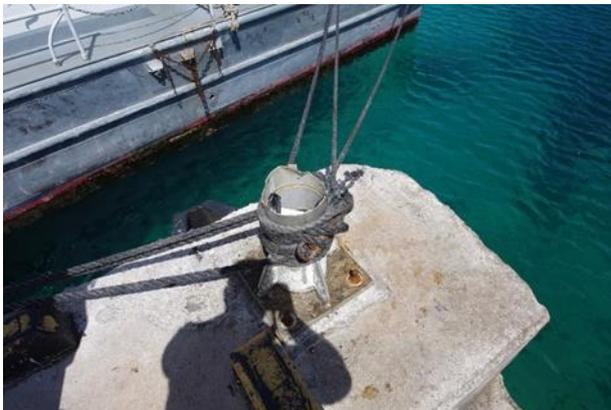
11. The structure is made of concrete and the surface of the dock is in good condition. The port is fenced and security is in place at the main gate. There is potential access via the boat ramp. There is relatively little lighting except at the main gate area and one light post was broken and being used as a bollard. The restricted area around the generator set is open and fencing is damaged and/or non-existent. Several drums (likely to be fuel and/or oil) were stored adjacent to the generator. Some minor oil leakage was observed around the generator although there is no suggestion this oil is released into the marine environment. There is a small bunded area in front of generator (presumably for storage/delivery of fuel or of empty drums) which has been breached. Some of the fenders at the port were observed to be damaged although the majority were in good condition.

Broken Light Pole at Uliga

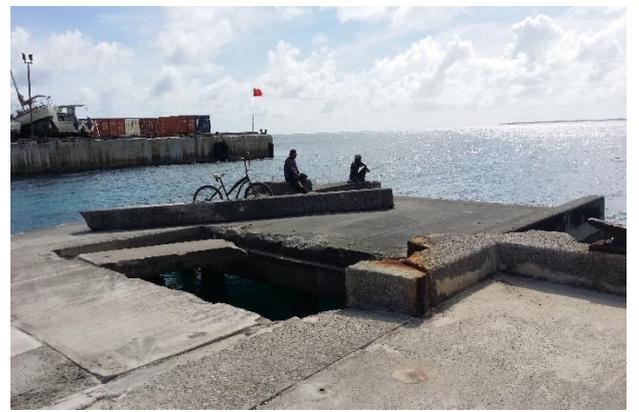
19. Ebeye Port Manager indicated that two main issues occurred at the port. The first is that fuel is transhipped by trucks to the power station through town. Secondly, the port manager advised that larger vessels needed to tie up on a bollard on the ferry terminal, although no bollard could be located.

Supposed Bollard on Ferry Terminal - Ebeye

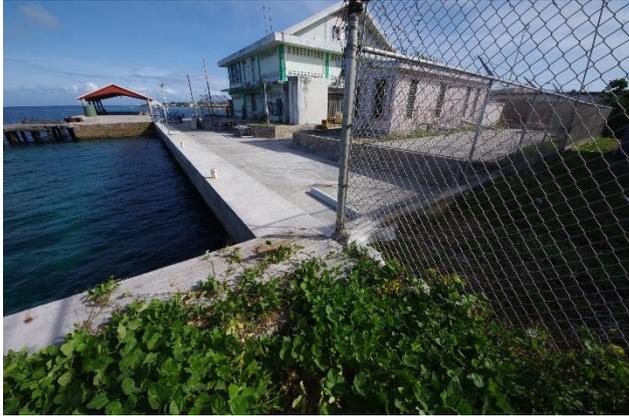
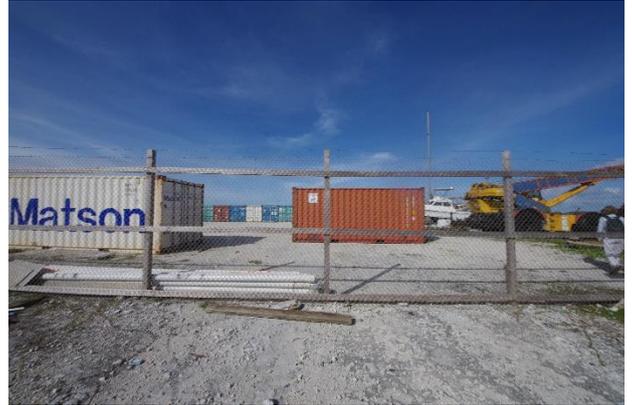
20. The port is poorly fenced, and there are gaps where access can be obtained through although there is signage restricting entry. Fencing at several other locations are also deficient in terms of preventing unauthorized access. There is relatively little lighting except at the main gate area. There are no fixed fenders at the port; the fenders are large tires.

Fence at Ebeye Port

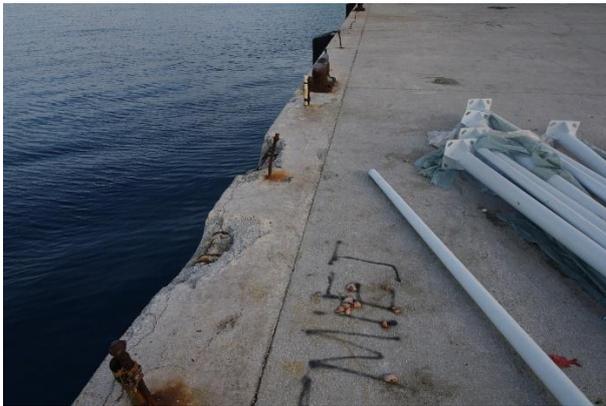
Corrosion of Dock - Jaluit

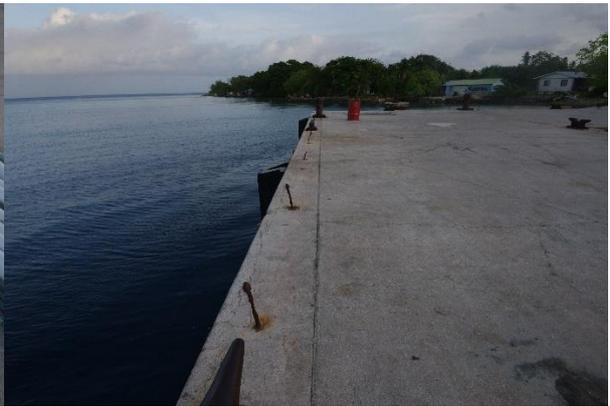
23. There are limited facilities associated with the wharf; there are fences or there is currently a number of rotted steel struts sticking out of the wharf itself which are a safety hazard. There is a single lane road that lead from the wharf to the village of. On the landward side, there are stairs allowing access to smaller vessels.

Rusted Steel Struts - Jaluit

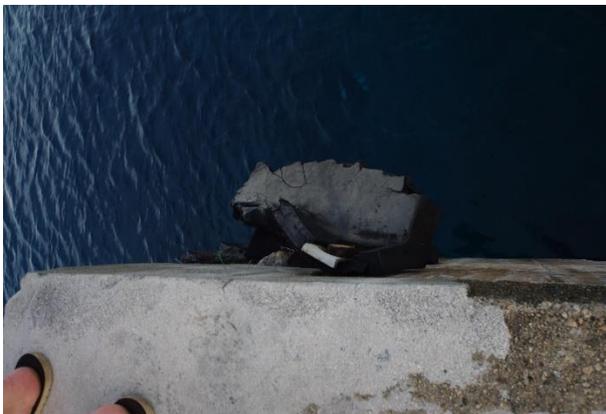
22. Based on Google Earth imagery, the structure is about 33 meters long by 10 meters wide. The port structure itself is in excellent condition and recent works have been undertaken on the dock. New oval fenders have been installed on the landward side of the wharf and new light towers are currently being installed. There is one damaged fender on the north western corner of the wharf.

Damaged Fender - Jaluit

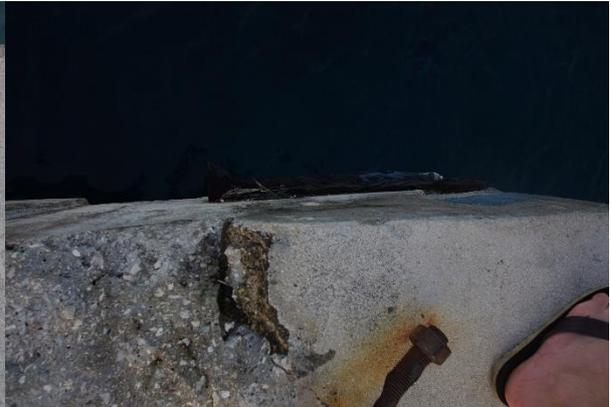
Corrosion of Jaluit Dock

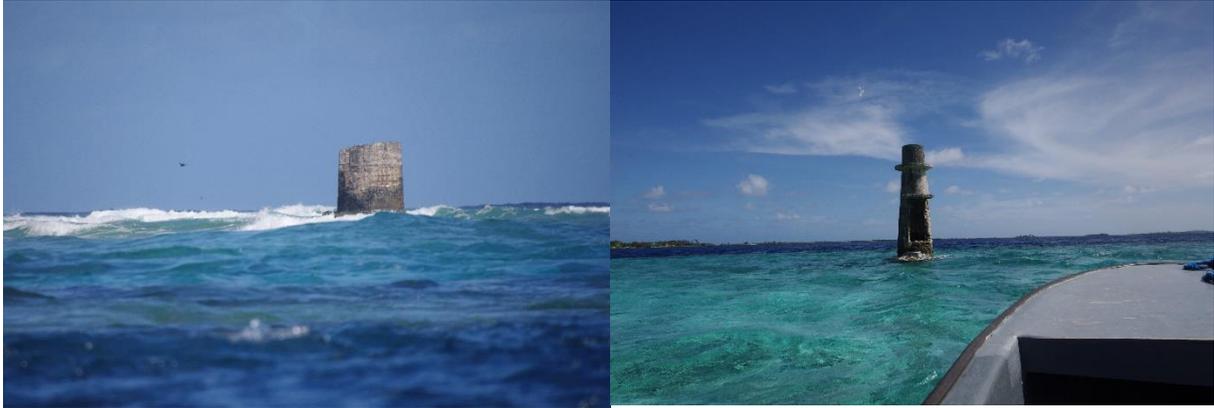
24. There are two un-operational navigational aids. One is located at the entrance to the lagoon and was installed by the Japanese. It is essentially a cylindrical concrete structure with no infrastructure on top. The second was also build by the Japanese and is located within the lagoon itself. Its location could be off putting as it is located well inside a reef and as such, it could be considered a shipping hazard.

Outer Channel Navigational Aid - Jaluit

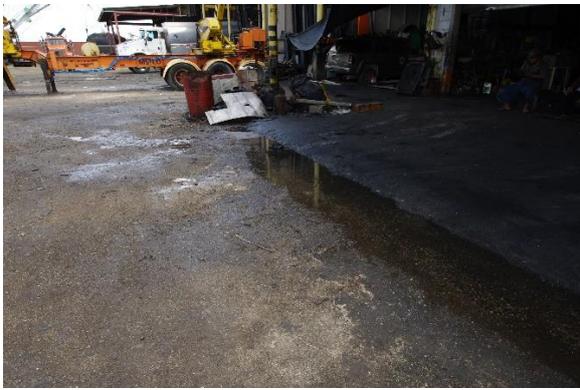
Tuna being unloaded at Delap

Oil leakage at Delap Port

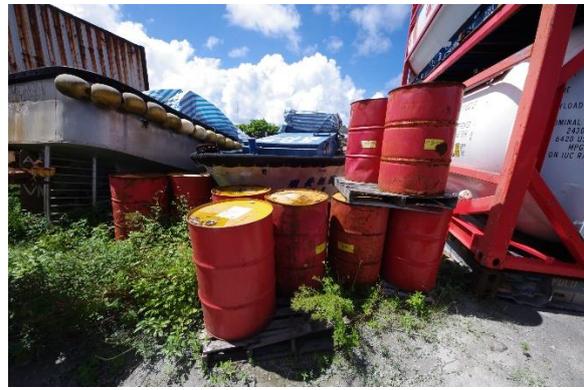
Oils at Delap Port

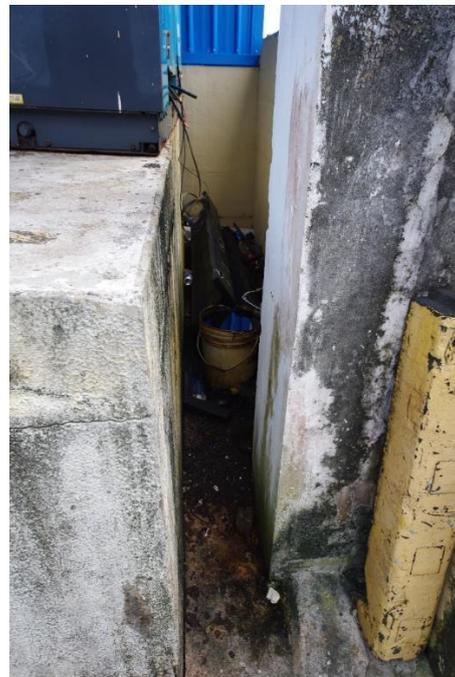
Oil leaking at Uliga Port

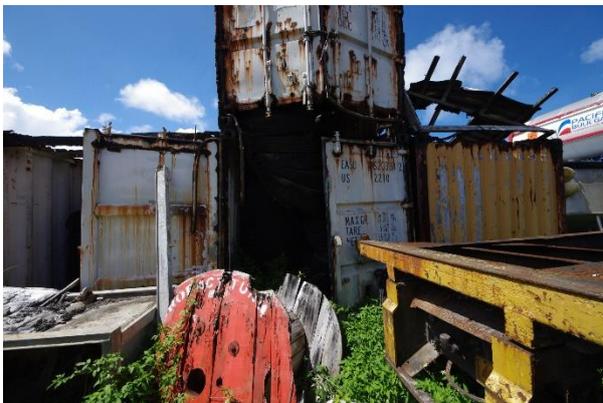
34. All the ports visited in RMI had waste issues in varying scales, although the issue is greatest at ports with containers yards. It is estimated that between 30 to 40% of Delap is lost to normal use due to waste. Common waste was dumped/scrap cars, trucks and other machinery, tires, oil/fuel drums, old containers that were no longer useable, batteries, fishing gear and other items. This waste can cause environmental, health and safety risks for port users and the environment.

Rusted Containers at Delap Port

36. It is noted that under the ESMF/ESMP, the MIMIP will develop waste management plans for the MIMIP activities, however, if more comprehensive port waste management plans do not exist then it is recommended that consideration to the development be considered. Examples of port waste are shown in Figure 21.

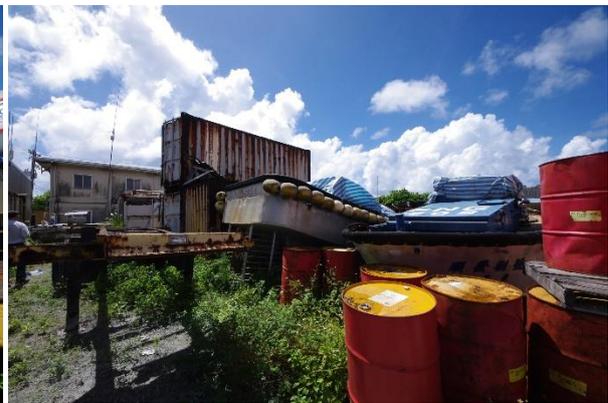
Waste at Delap Port

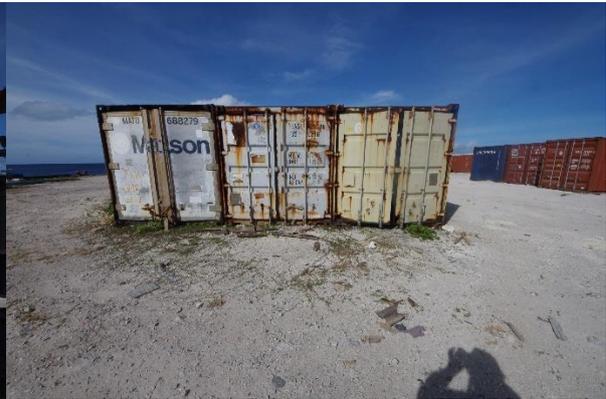
Rusted Containers at Ebeye Port
