# Marshall Islands Maritime Investment Project

## Wotje Site Inspection of Dock Facilities

2<sup>nd</sup> March 2019

Descriptive Report to Inform ESMF/ESMP

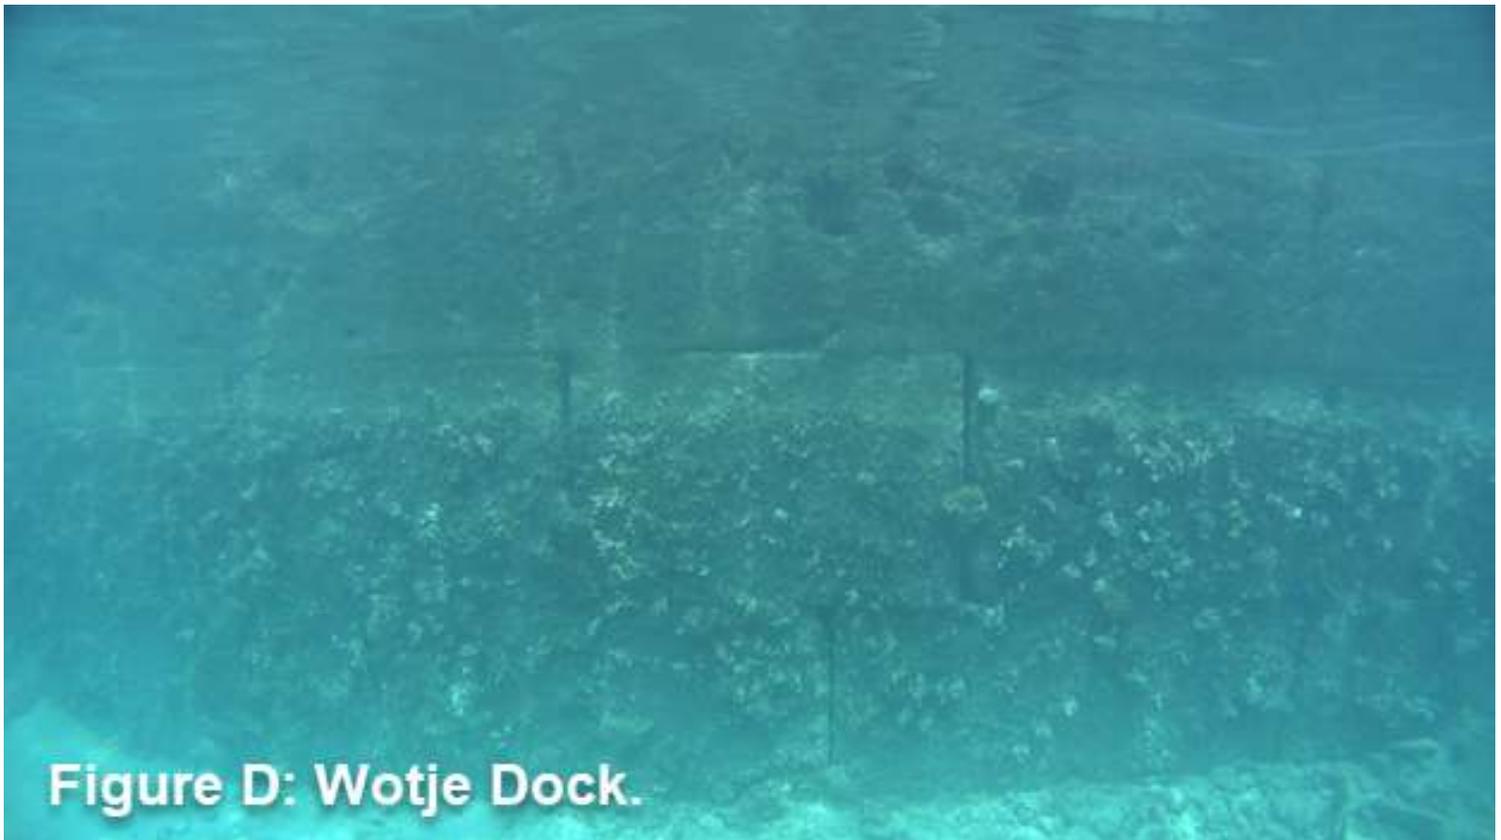
On the south side of the dock there is an approximately 30m length of side wall, starting at the beach end, where the topping beam is starting to fail by rotation and the top is leaning out (away from the dock).

The surface of the dock is gravel / fill material with grass and small weeds growing on it. Presumably there has been some topping up of the fill material over the years

The blocks appear to be in good condition with little or no reduction in size. The blocks do not appear to be suffering from reinforcing steel corrosion. Between some of the blocks there are small gaps in the joints that are allowing wave action to erode the fill.

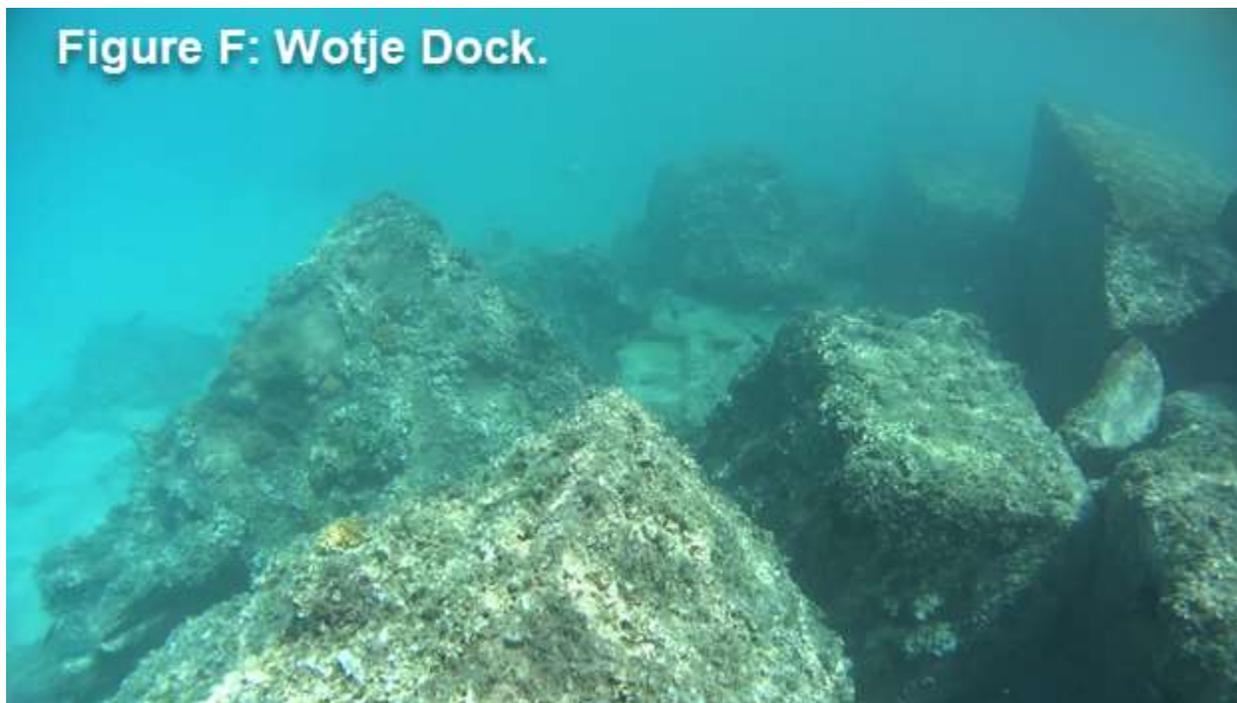
**Figure F: Wotje Dock.**

A WWII bomb blast scattered the large blocks at the end of the dock, allowing the wave action to erode the fill material – this has made the end of the dock (the position with the most access to the deeper water) completely unusable except for swimming. The bomb blast also destroyed the crane and crane dock structure, which was housed on a perpendicular dock extension / widening at the end of the dock; the large blocks are scattered on the seabed and some of the rusted steel crane assembly remains.

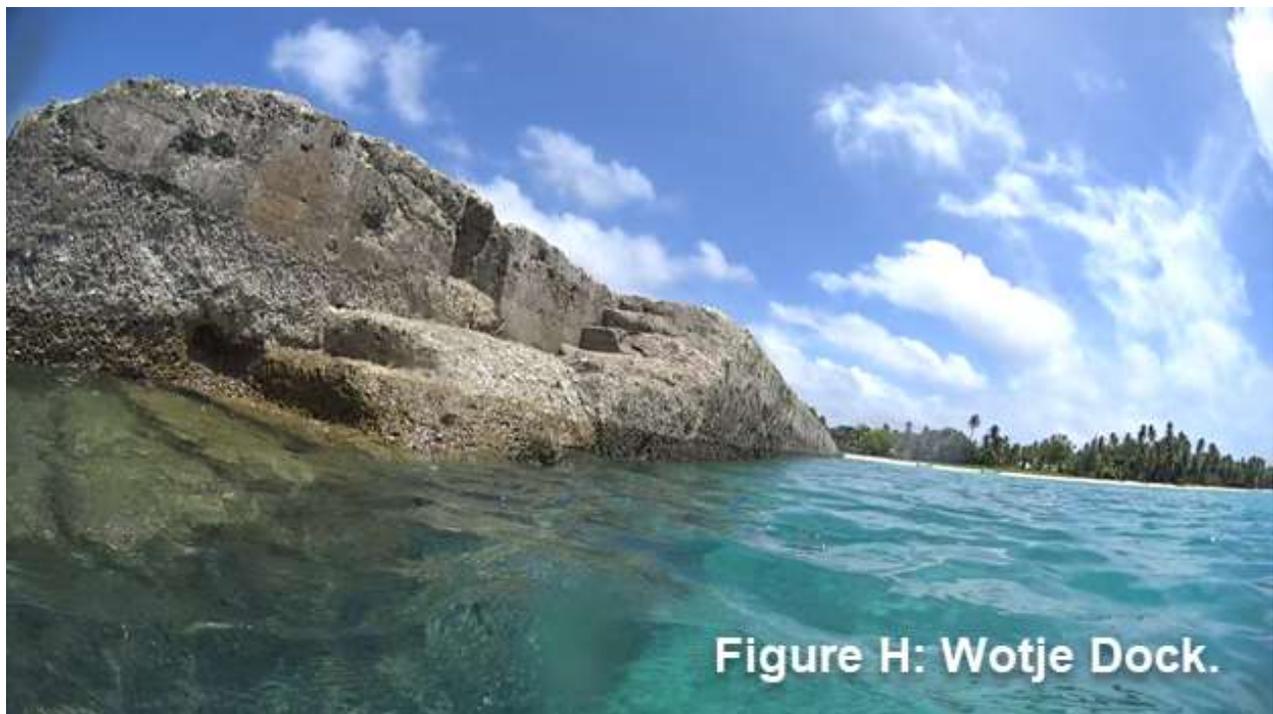
The single set of stairs to service smaller vessels is not easily accessible, and while useable, is not in good condition. These stairs appear to be suitable only for swimmers / spear fishers.

4. Consideration should be given to upgrading the steps, installing a crane and installation of passenger/cargo shelter.
5. Any works on the dock/ramp will fall under the provisions of the Historic Preservation Act 1991, and the HPO.
6. The dock appears to experience relatively low levels of use from the point of view of visiting boats.
7. Effective screening of visiting vessels is maintained by locals. We observed that Walgov Police Officers escorted passengers from a visiting superyacht.
8. There is evidence [Annex 2] of many bollards/cleats having been damaged – apparently by recent barge activity. These mooring structures warrant repair/reinstatement.
9. Remedial works can be undertaken on the dock without works affecting the seabed.

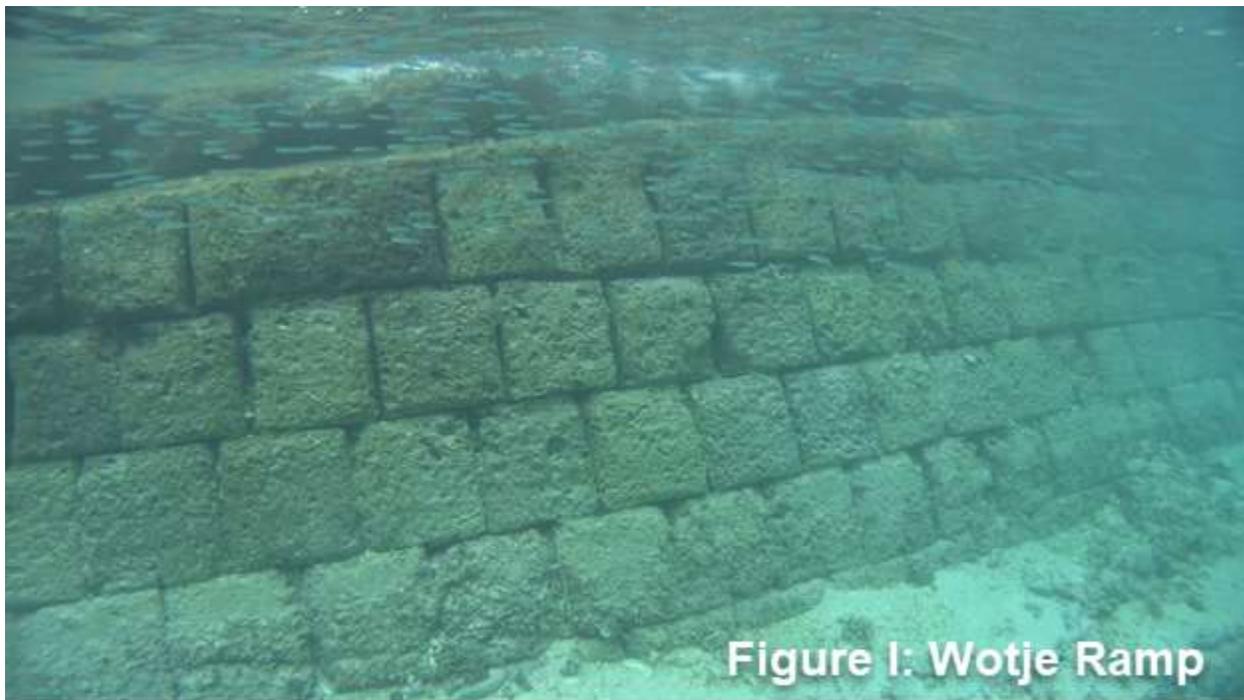
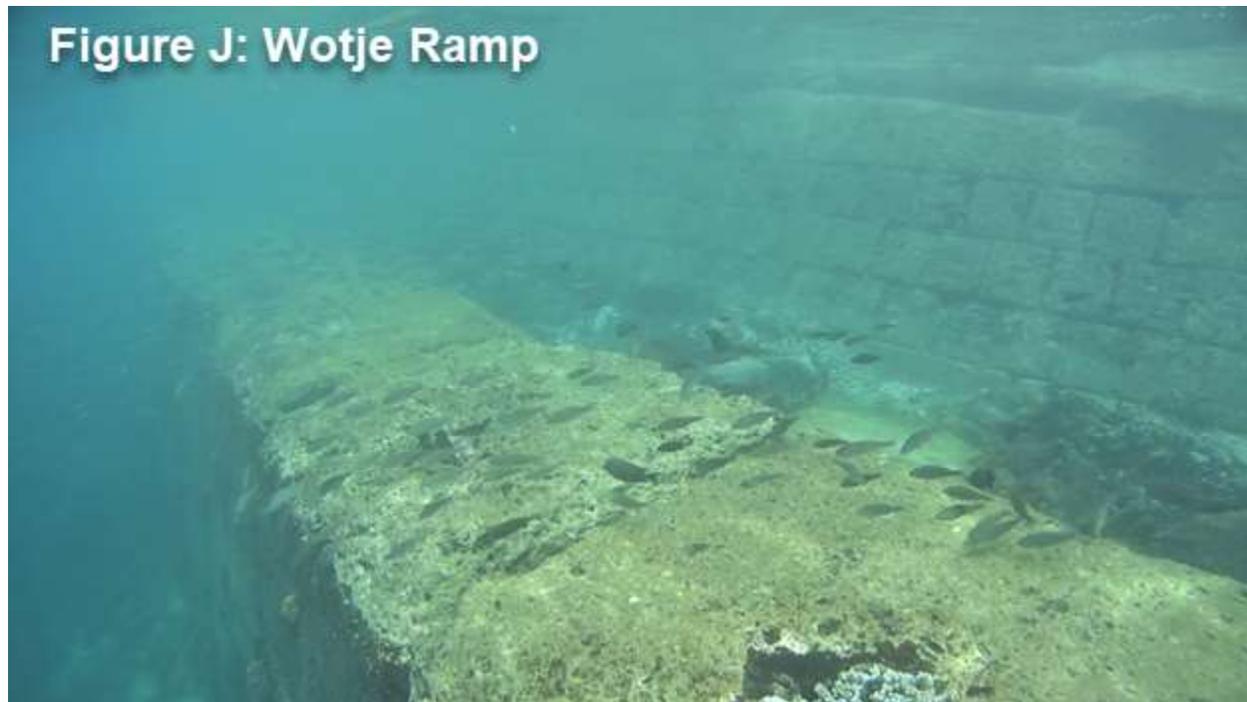
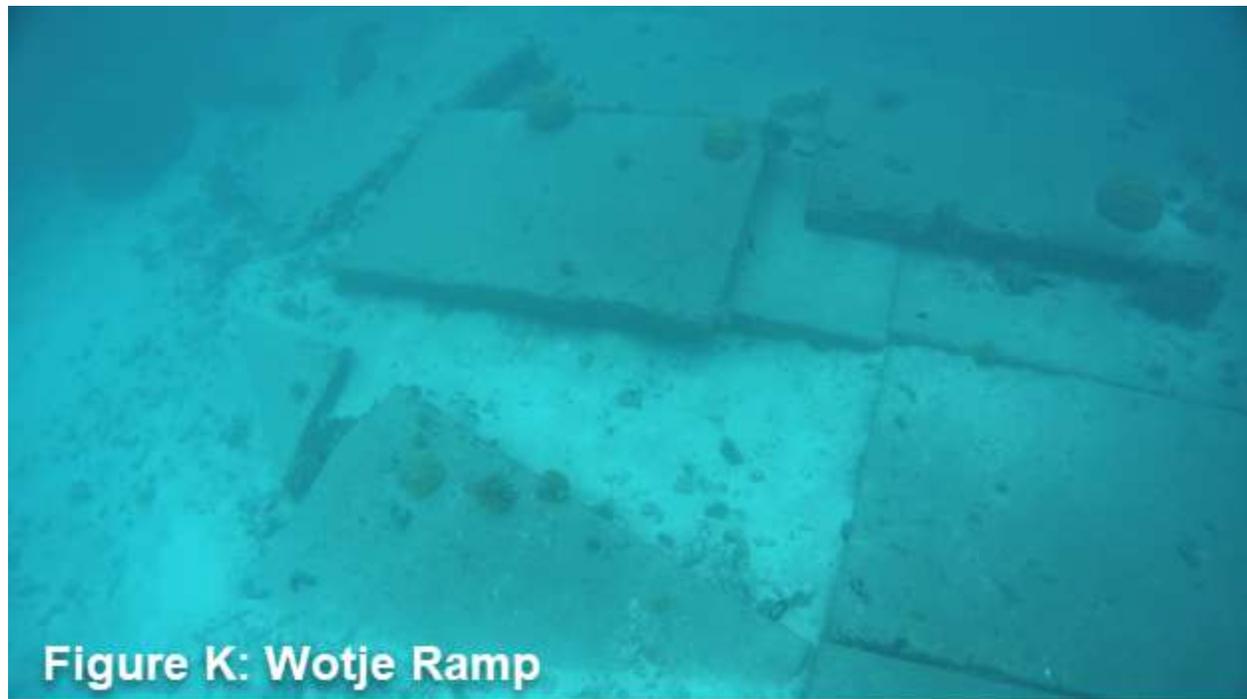
The sea plane ramp is built from small solid concrete blocks on a sloping wall with large concrete blocks supporting and protecting the smaller block walls in deeper water and as necessary. The larger protecting blocks are positioned in a line parallel to the north side of the ramp for approximately 30m in the deeper end of the ramp and on the southside only adjacent to the sloping ramp. There appears to be no bomb damage, however the end sloping ramp has a section of concrete surface slabs missing and the fill under it was visibly eroding from wave action. Some of the small sloping blocks appear to have deteriorated over time and there is erosion taking place from between the smaller concrete blocks.

The bottom of the sloping ramp has sections of concrete slab that have been displaced, presumably by wave action.

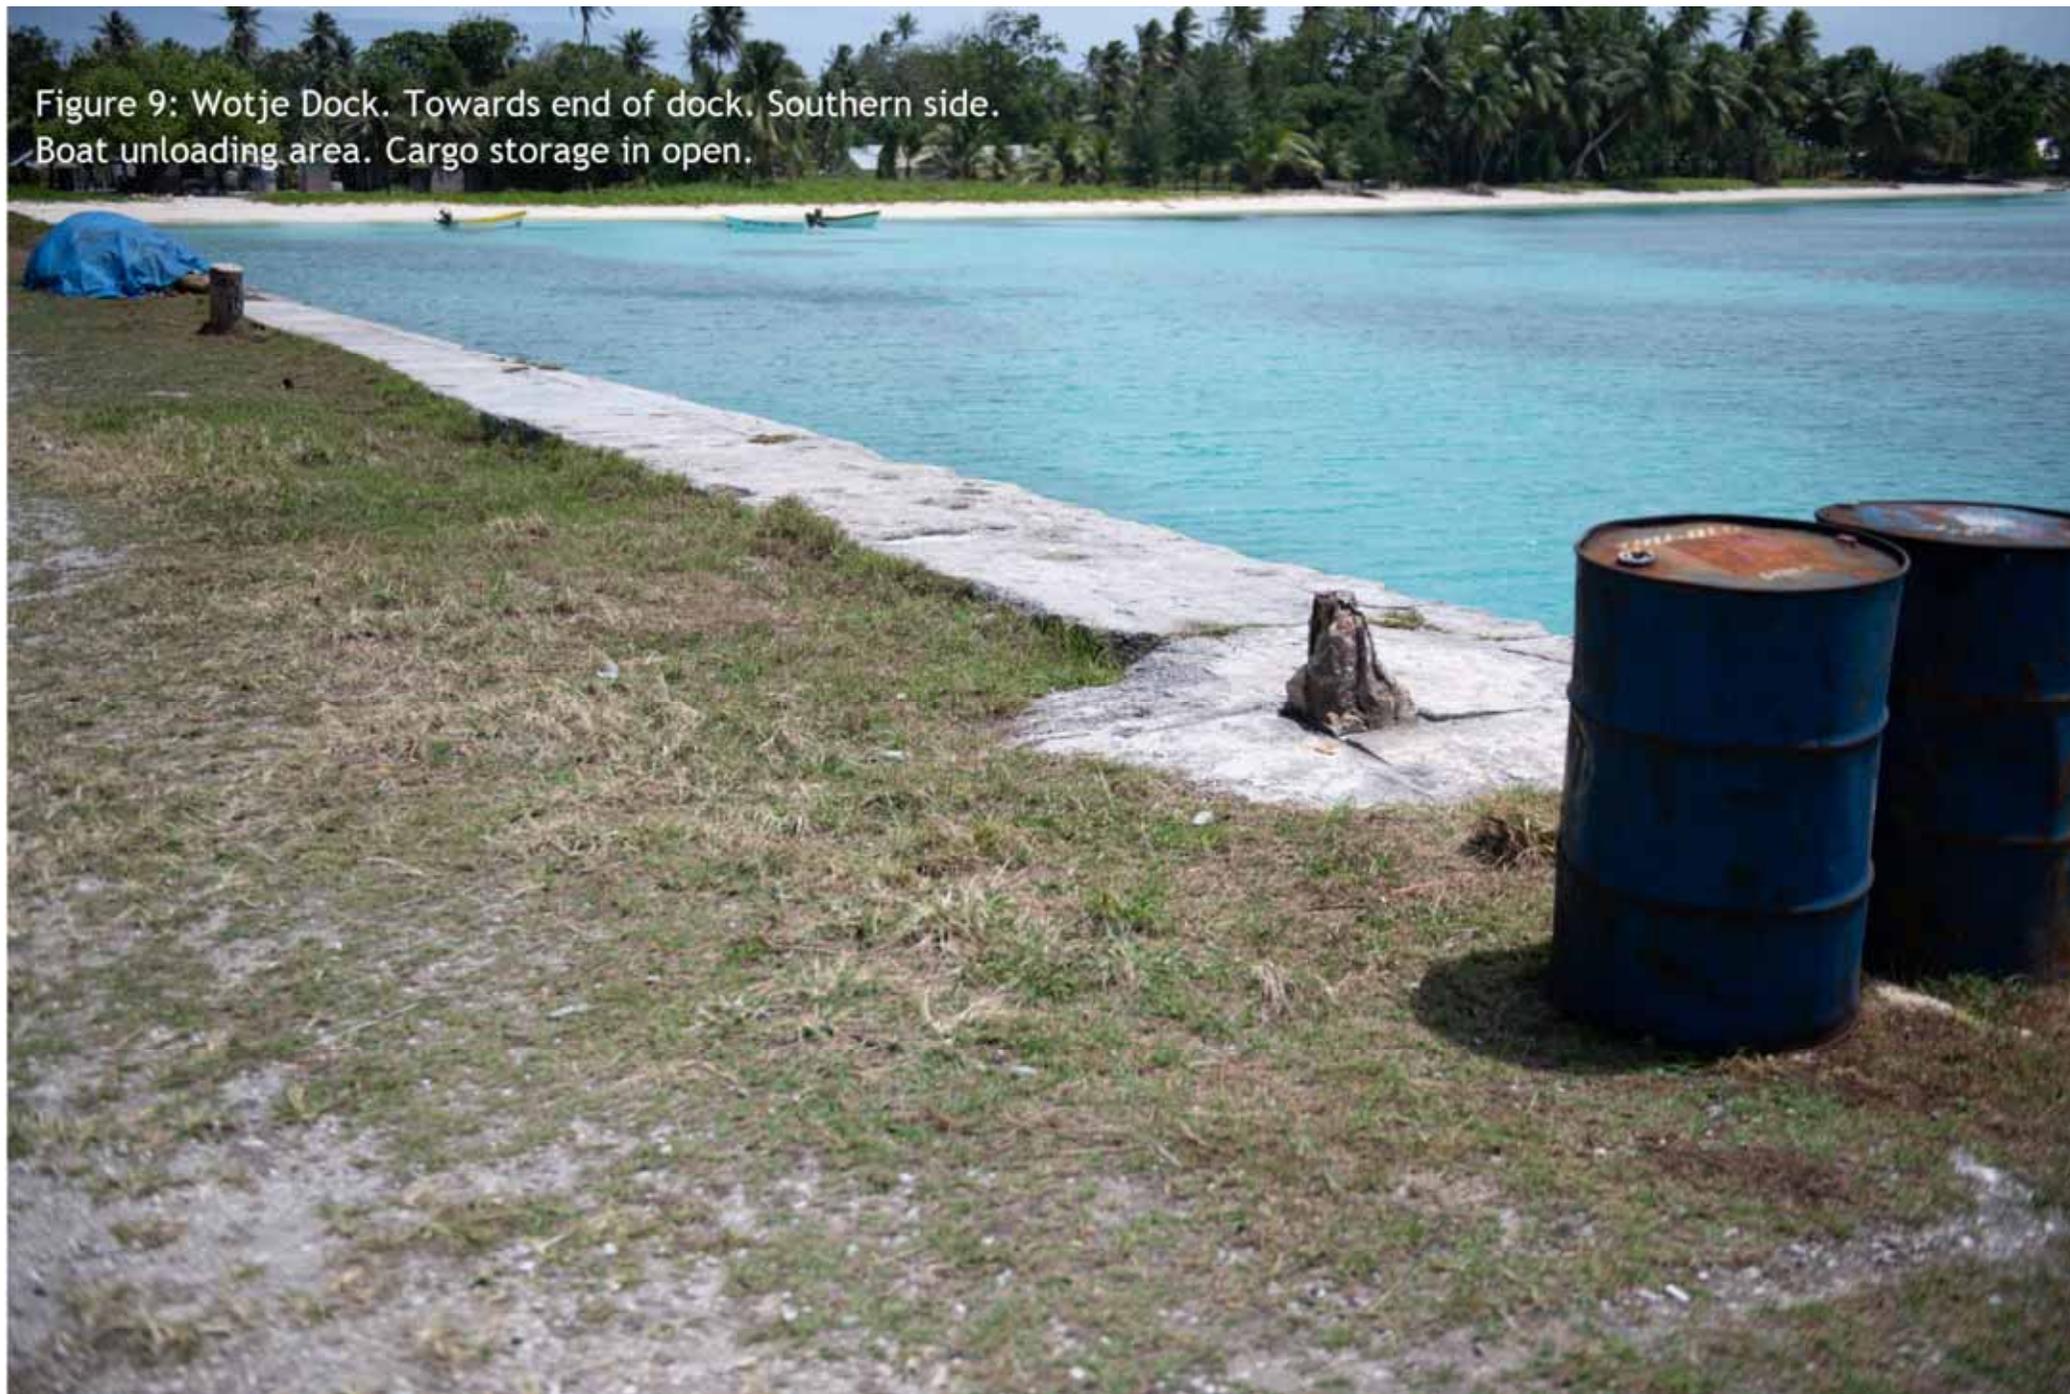
Figure 10: Wotje Dock. Towards end of dock. Southern side. Boat unloading area. Corroded bollard
