# **Marshall Islands Maritime Investment Project**

### Environment and Social Management Plan

Reference: PA3000-RHD-RP-ES-0001

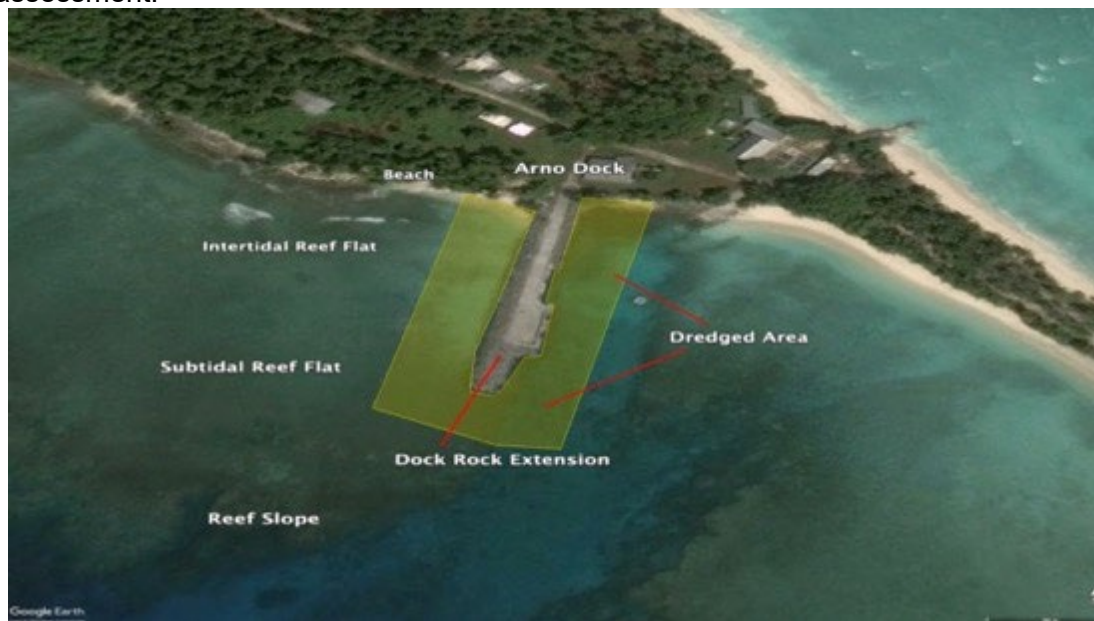
**Figure 2:** Free Diving site assessed for Arno dock during the marine benthic assessment.

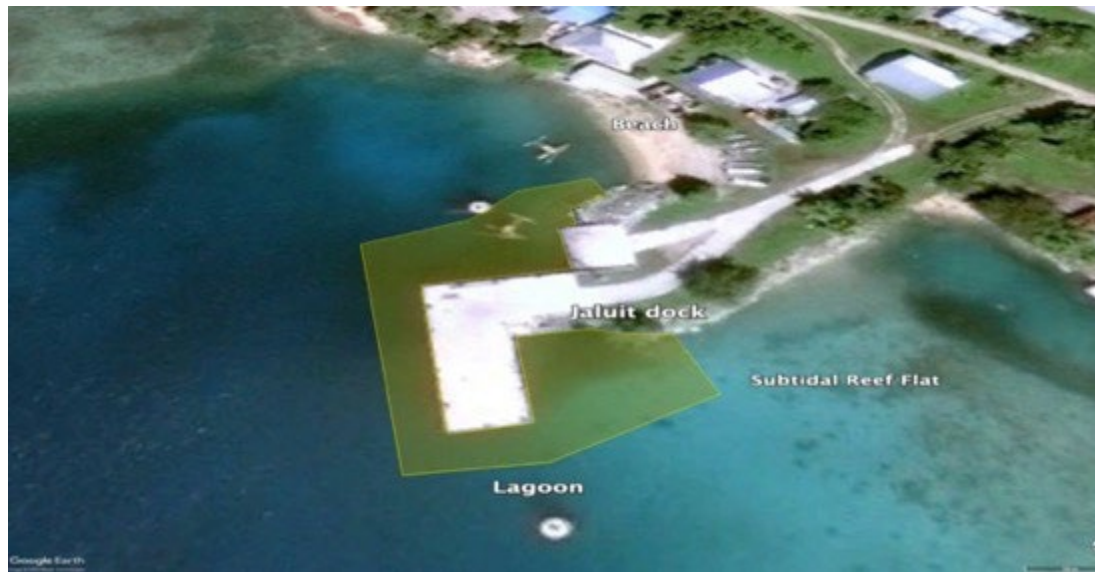
**Figure 3:** Free Diving site assessed for Jaluit dock during the marine benthic assessment.

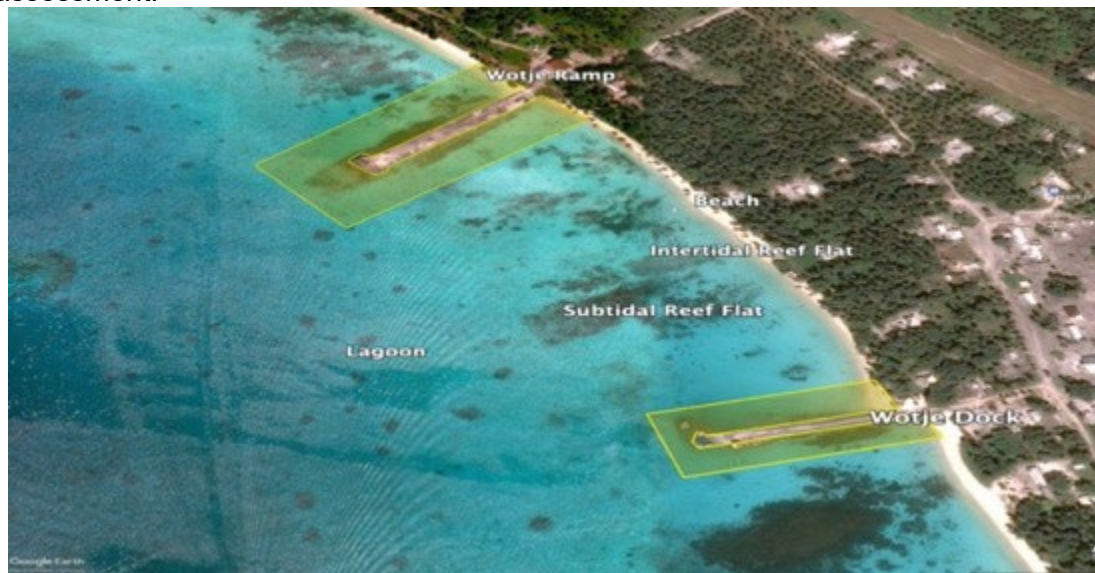
**Figure 4:** Free Diving site assessed for Wotje dock and ramp during the marine benthic assessment.

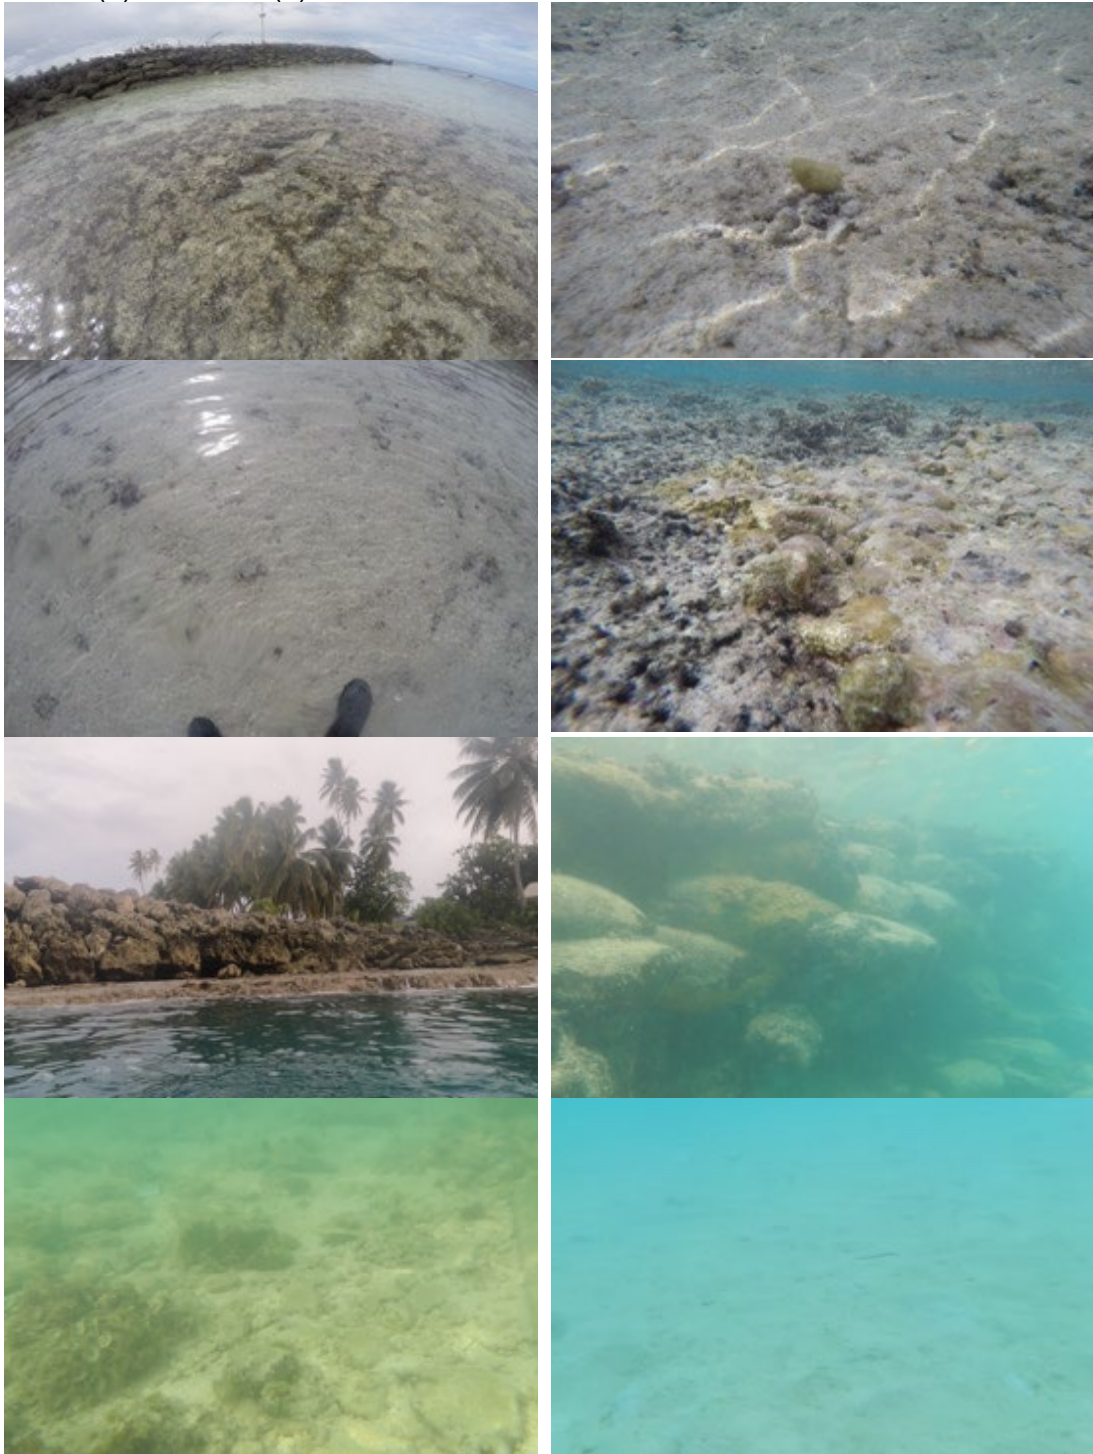
**Plate 9:** Representative photos of the benthic substrate associated with the intertidal reef flat (a) north and (b) south of Arno dock.

Exposure during low water and the high level of suspended sand based silt/substrate (refer Plate 9) located in the north and south respectively of the dock has a significant detrimental effect on recruitment and survival of sessile benthic marine life. This has resulted in a paucity of sessile and mobile benthic invertebrate species throughout the areas assessed adjacent to the Arno dock.

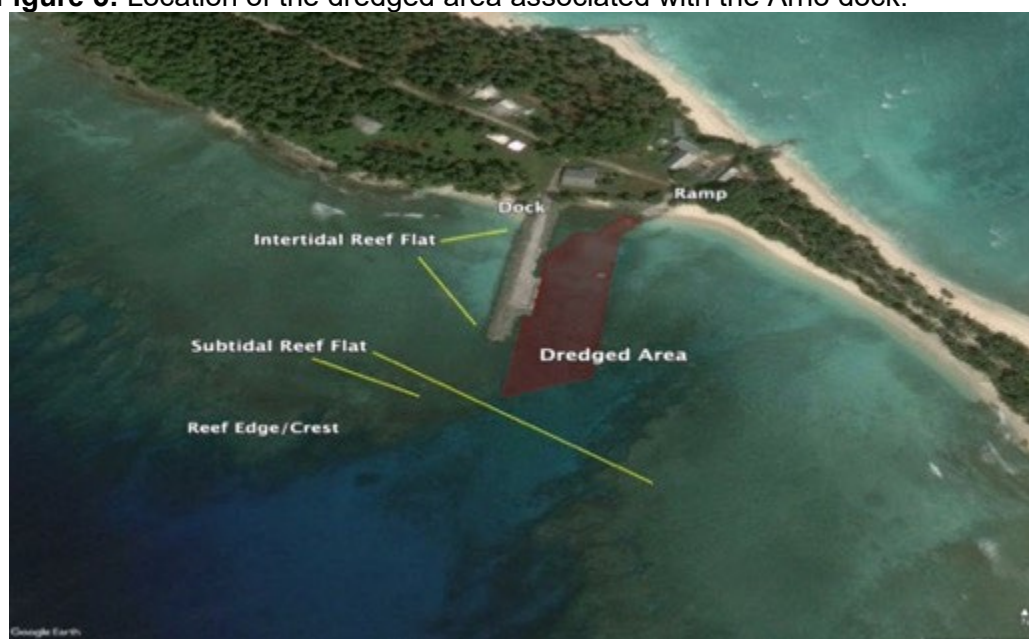
**Figure 5:** Location of the dredged area associated with the Arno dock.

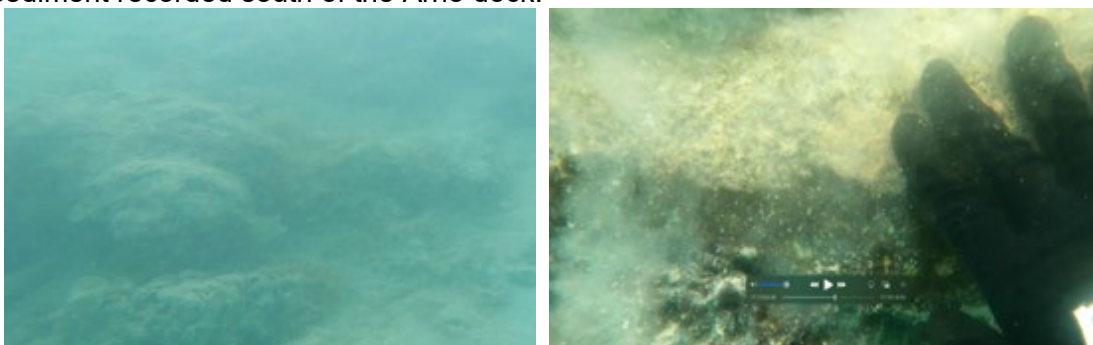
A large number of hard coral colonies located on or in close proximity on the southern side of the Arno dock recorded signs of stress due to high levels of suspended sediments, with significant hard coral mortality recorded throughout the area (Plate 12). There was a notable absence of large coral heads, table corals of any size and sea anemones at all sites assessed. There were no soft coral colonies and/or individuals located within these zones.

**Plate 12:** Hard coral mortality and stress resulting from high levels of suspended sediment recorded south of the Arno dock.

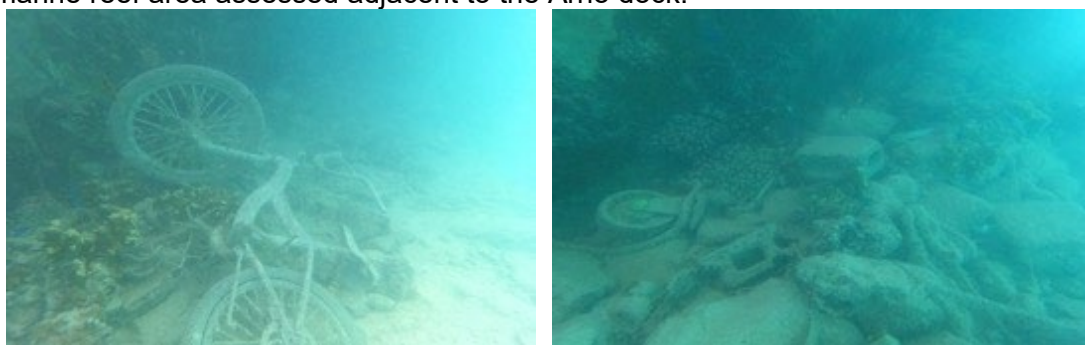
The marine benthic environment associated with the dock contained a small amount of anthropogenic used material and machinery (Plate 17) of which most was located on the southern side of the dock. A benthic physical cleanup of this material is recommended.

**Plate 17:** Anthropogenic garbage located during the marine assessment within the marine reef area assessed adjacent to the Arno dock.
