Republic of Marshall Islands Maritime Investment Project

Description of Existing Ports

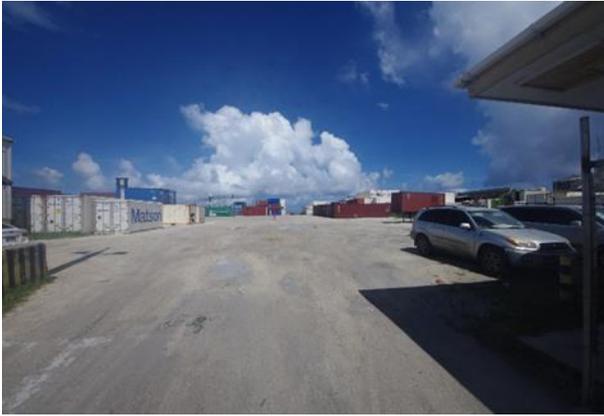
4. The container yard is 30,000 m² of crushed coral base. The surface is very uneven in places and could present safety issues for users. Water pooling was observed within the yard during the site visit immediately after rain. RMIPA indicated that between 10,000 and 30,000 Gross Registered Tonnage could be put through the port. The port has the capacity for 500 twenty-foot equivalent units (TEUs). There are presently ten (10) reefer stations. During the site visit in December 2018, numerous purse seine vessels were alongside however in February 2018, no vessels were observed alongside the port.

Delap Container Yard

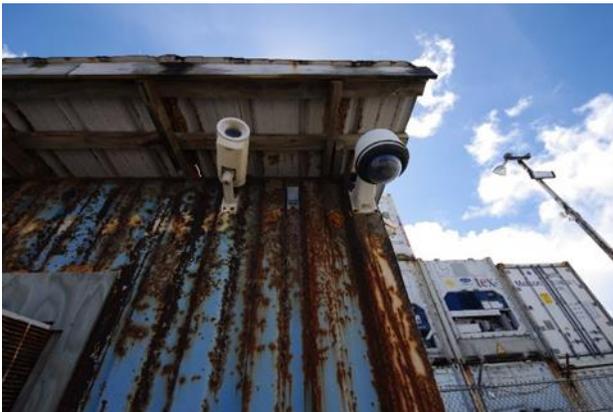
5. Located to the east of the main wharf, the eastern berth is dedicated to local trading vessels along with copra transporters.
6. The port is poorly fenced, and there are gaps where access can be obtained through although there is signage restricting entry. Fence between the neighboring power station and the port is non-compliant in terms of security. Fencing at several other locations are also deficient in terms of preventing unauthorized access. There is relatively little lighting except at the main gate area. Vessels mooring alongside have their lights on at night.

Security Camera - Delap

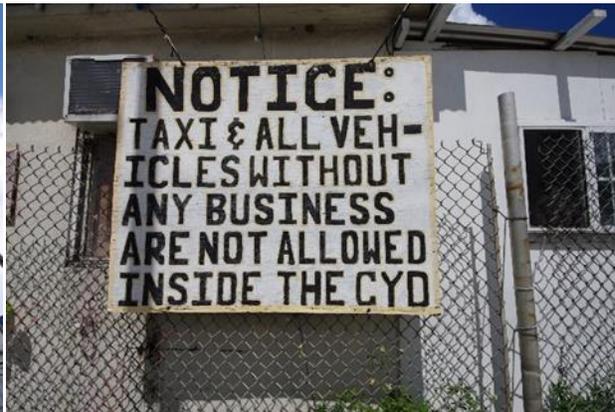
Sign at front gate of Delap Port

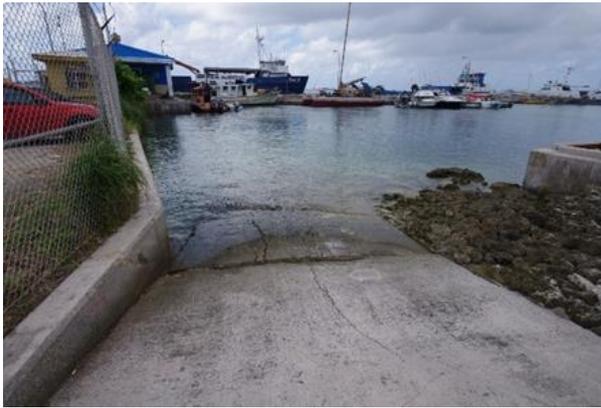
11. The structure is made of concrete and the surface of the dock is in good condition. The port is fenced and security is in place at the main gate. There is potential access via the boat ramp. There is relatively little lighting except at the main gate area and one light post was broken and being used as a bollard. The restricted area around the generator set is open and fencing is damaged and/or non-existent. Several drums (likely to be fuel and/or oil) were stored adjacent to the generator. Some minor oil leakage was observed around the generator although there is no suggestion this oil is released into the marine environment. There is a small bunded area in front of generator (presumably for storage/delivery of fuel or of empty drums) which has been breached. Some of the fenders at the port were observed to be damaged although the majority were in good condition.

Boat Ramp at Uliga Dock

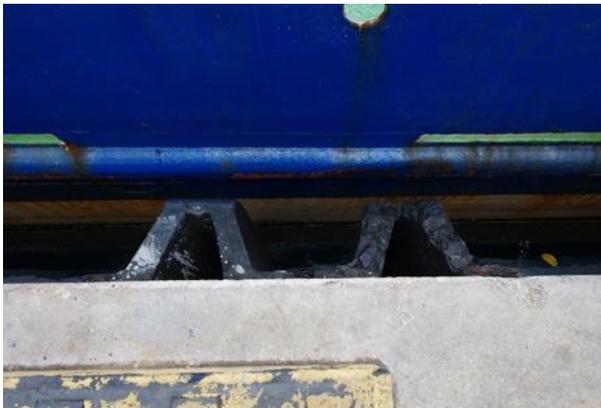
Fender at Uliga Dock

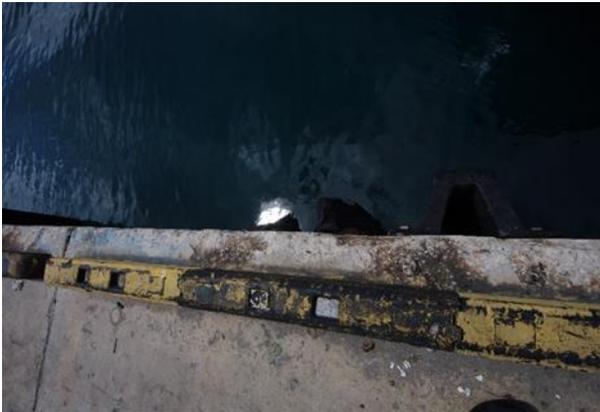
Fender at Uliga Dock

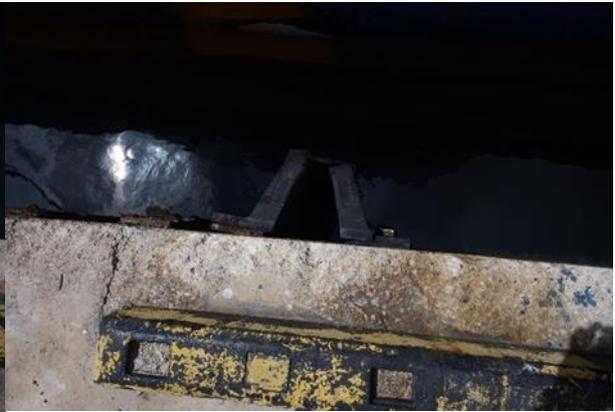
Fender at Uliga Dock

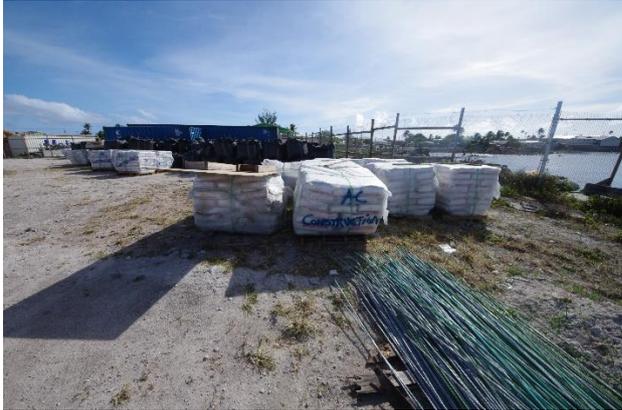
Cargo at Ebeye Port

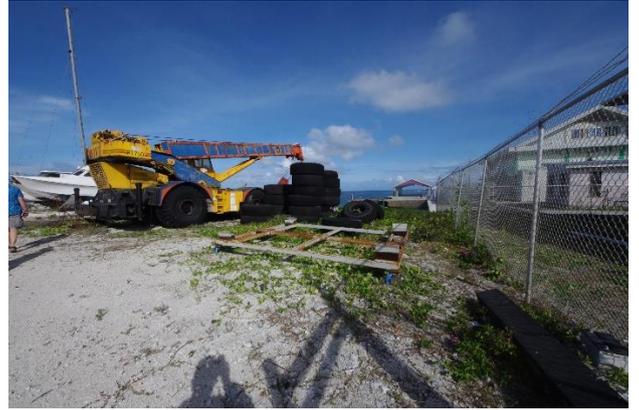
Old Machinery at Ebeye Port

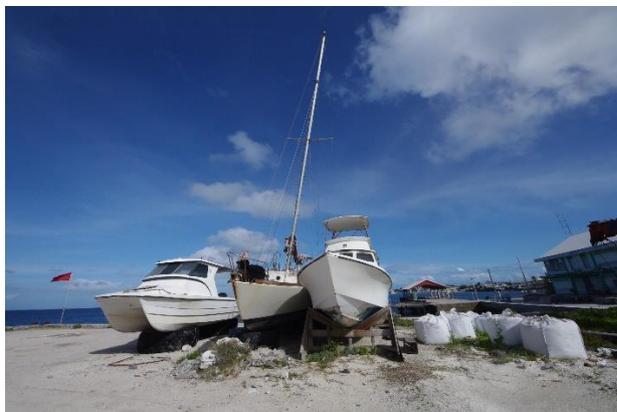
Three vessels on the hard at Ebeye

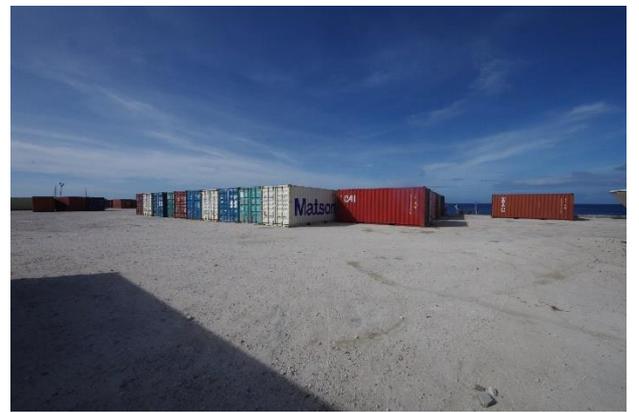
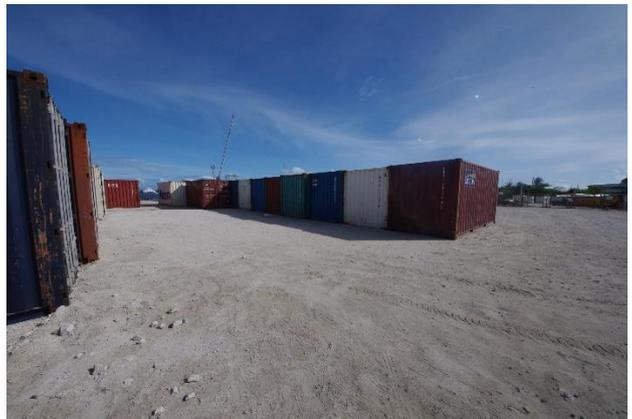
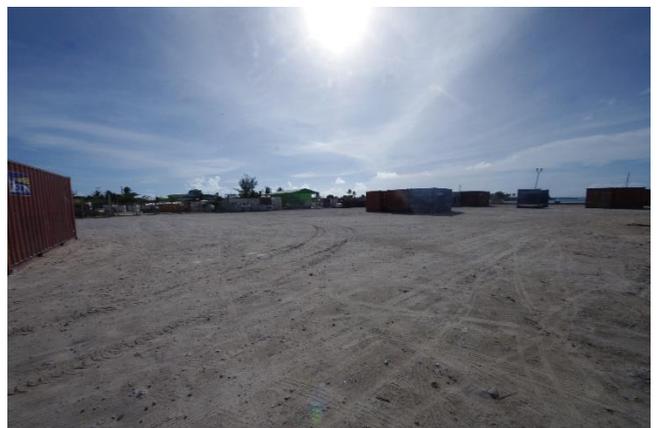
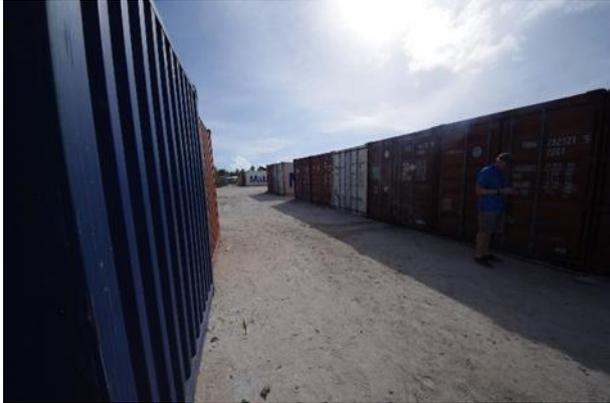
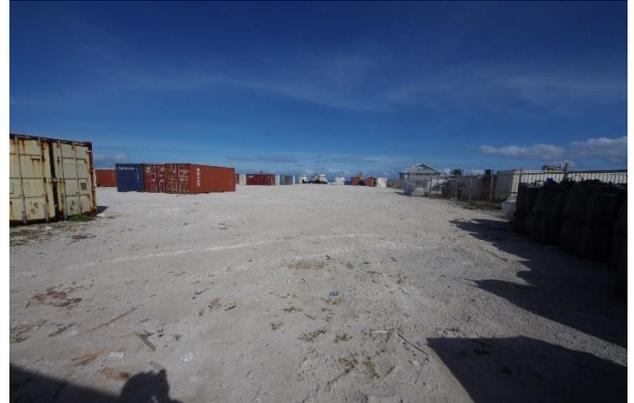
18. The container yard is 5,000 m² of crushed coral base. The surface is uneven in places and could present safety issues for users. The port has the capacity for 100 twenty-foot equivalent units (TEUs), although on the day the site was visited, it was badly organized with containers extremely close to the wharf front. There are no reefer stations. There are 20 people employed at the port.

Ebeye Port Container Yard

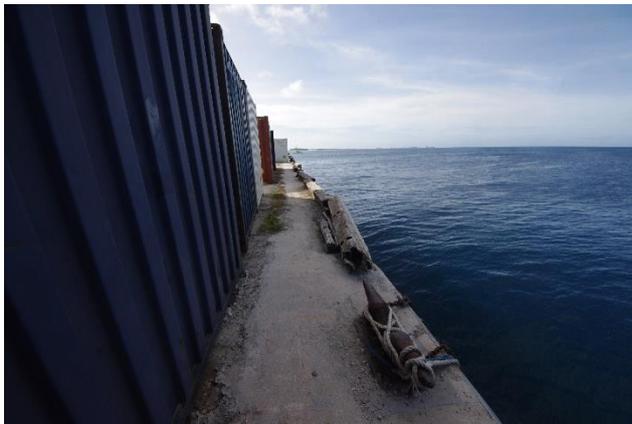
20. The port is poorly fenced, and there are gaps where access can be obtained through although there is signage restricting entry. Fencing at several other locations are also deficient in terms of preventing unauthorized access. There is relatively little lighting except at the main gate area. There are no fixed fenders at the port; the fenders are large tires.

Wharf Front at Ebeye Port

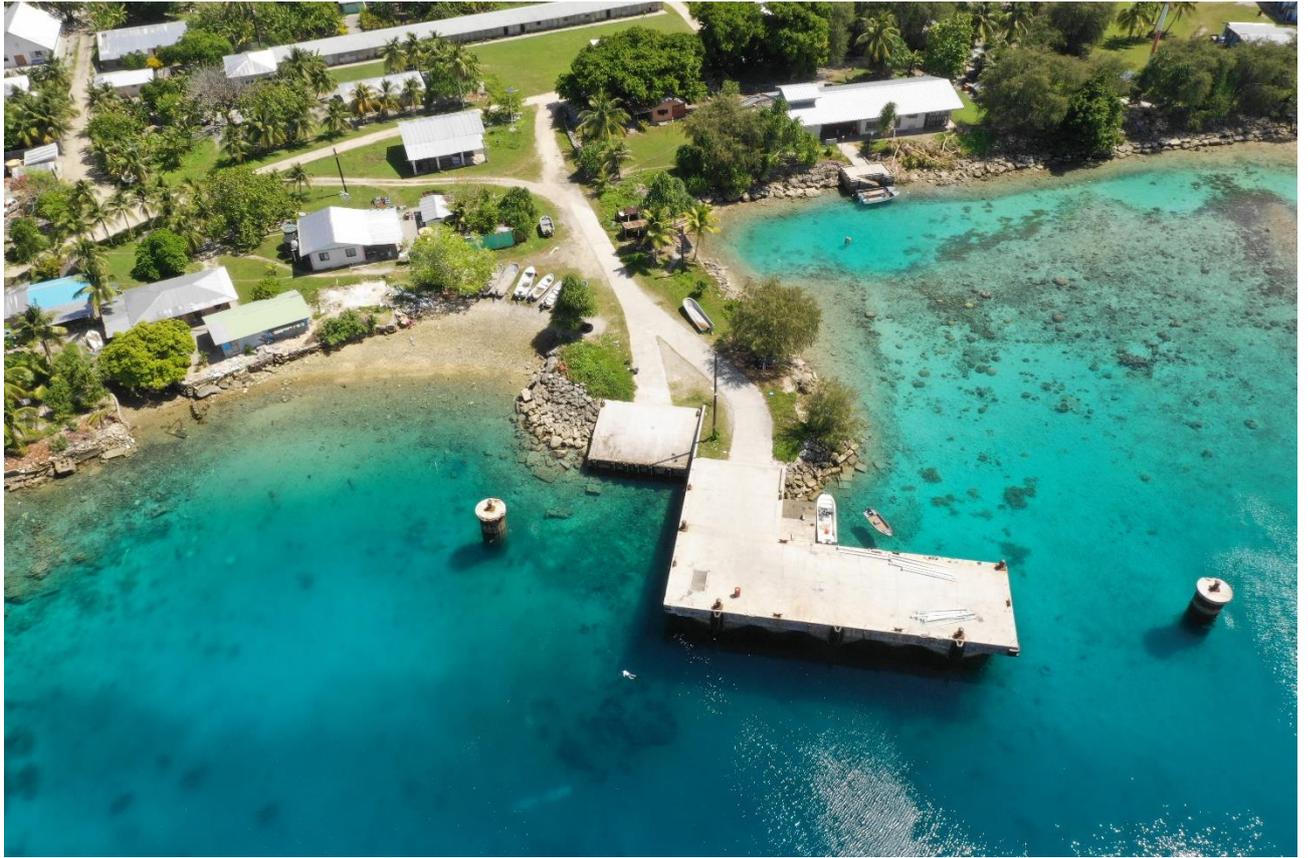
Figure 16 Aerial View of Jaluit Wharf⁴

22. Based on Google Earth imagery, the structure is about 33 meters long by 10 meters wide. The port structure itself is in excellent condition and recent works have been undertaken on the dock. New oval fenders have been installed on the landward side of the wharf and new light towers are currently being installed. There is one damaged fender on the north western corner of the wharf.

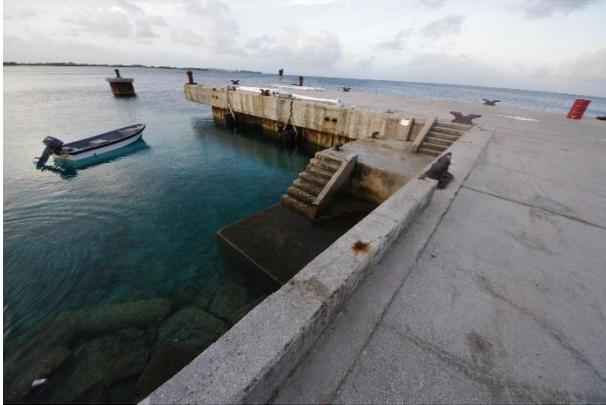
Landward Side Access - Jaluit

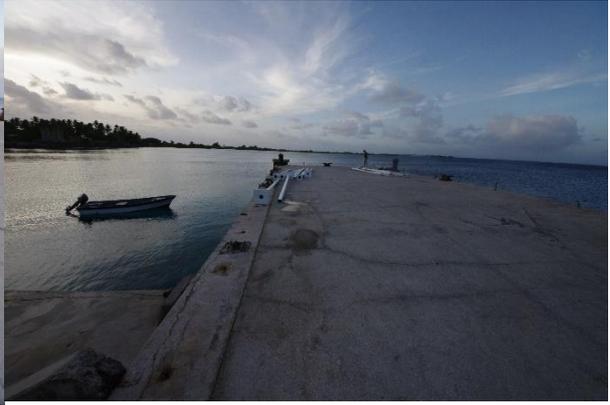
Dock with to be installed light towers - Jaluit

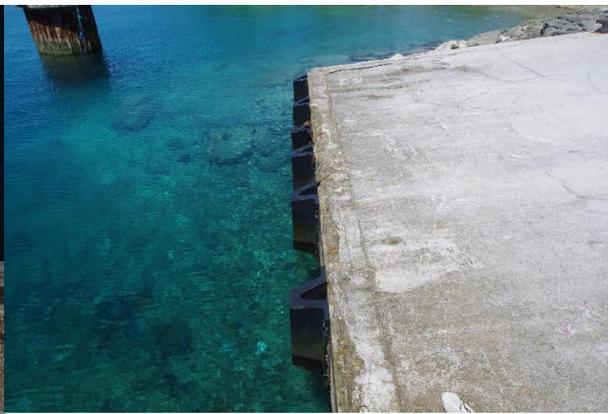
Roll On Roll Off Fenders - Jaluit

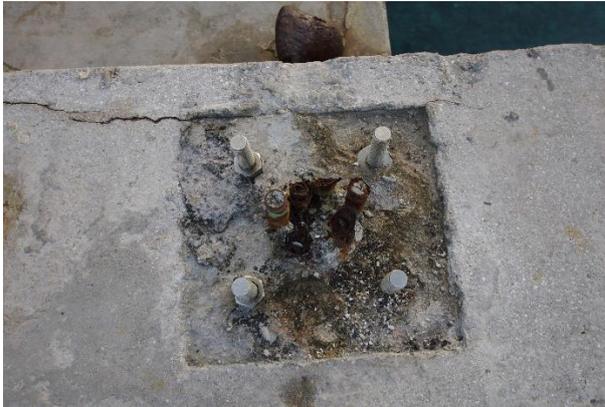
New Light Tower Fittings - Jaluit

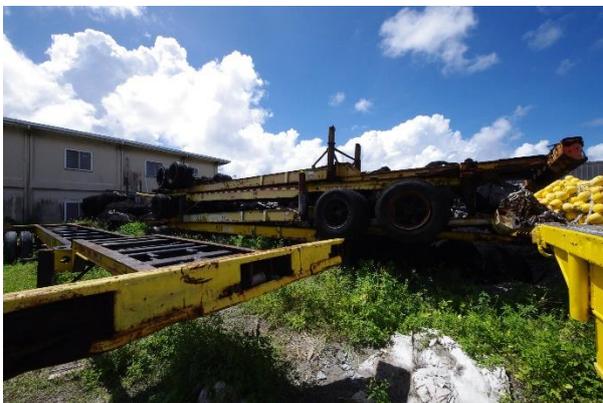
Old trucks at Delap Port

36. It is noted that under the ESMF/ESMP, the MIMIP will develop waste management plans for the MIMIP activities, however, if more comprehensive port waste management plans do not exist then it is recommended that consideration to the development be considered. Examples of port waste are shown in Figure 21.

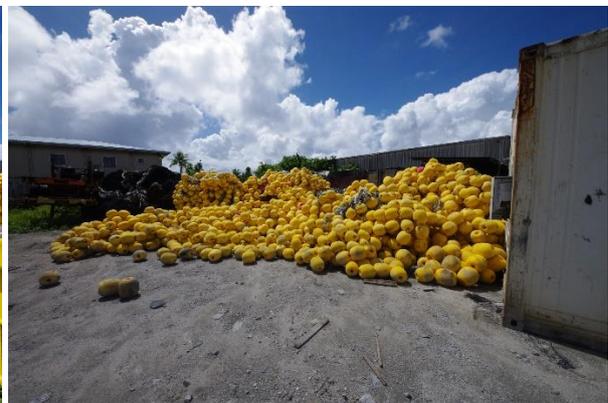
Old Fishing Gear at Delap Port

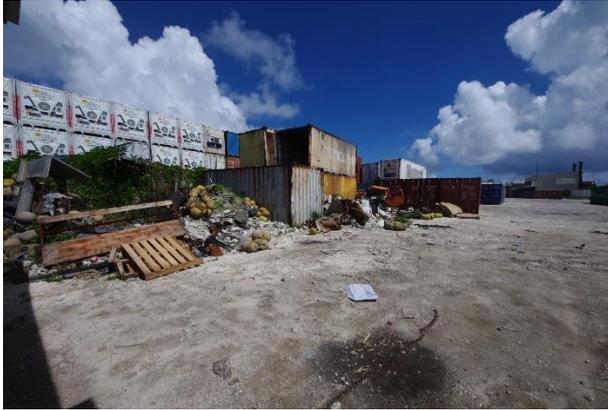
34. All the ports visited in RMI had waste issues in varying scales, although the issue is greatest at ports with containers yards. It is estimated that between 30 to 40% of Delap is lost to normal use due to waste. Common waste was dumped/scrap cars, trucks and other machinery, tires, oil/fuel drums, old containers that were no longer useable, batteries, fishing gear and other items. This waste can cause environmental, health and safety risks for port users and the environment.

Waste at Delap Port

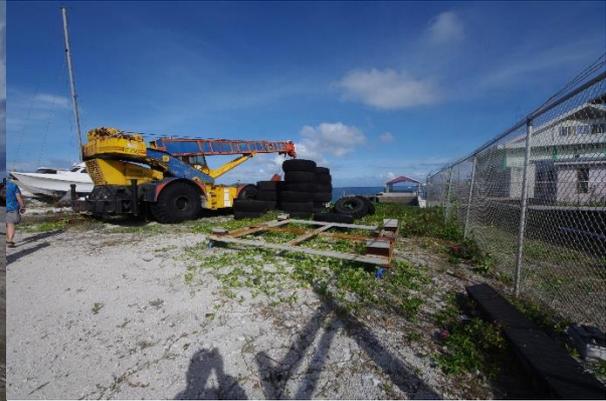
Waste at Ebeye Port

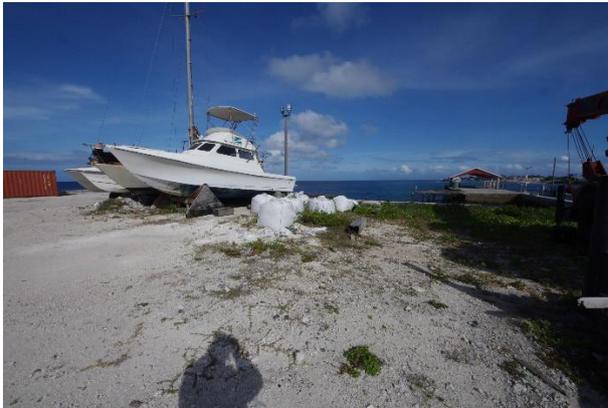
Old boats at Ebeye Port
